Extending Wood Crosstie Life:

Weathering Experiment Results

Indianapolis, IN – 2025.11.21

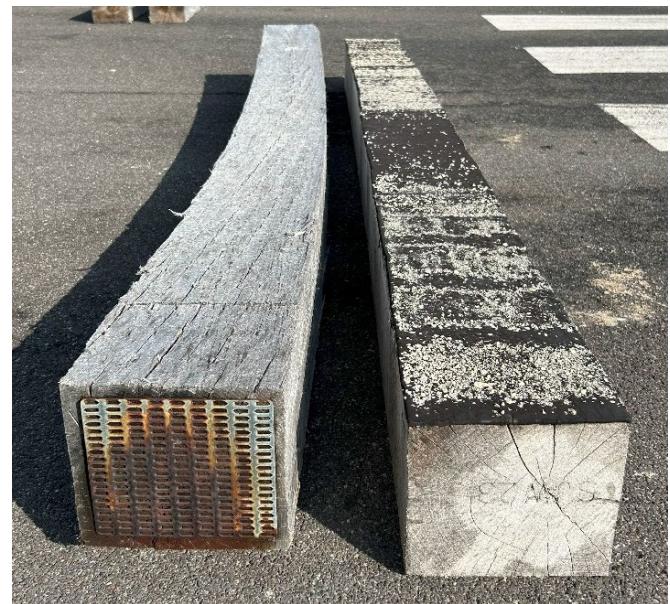
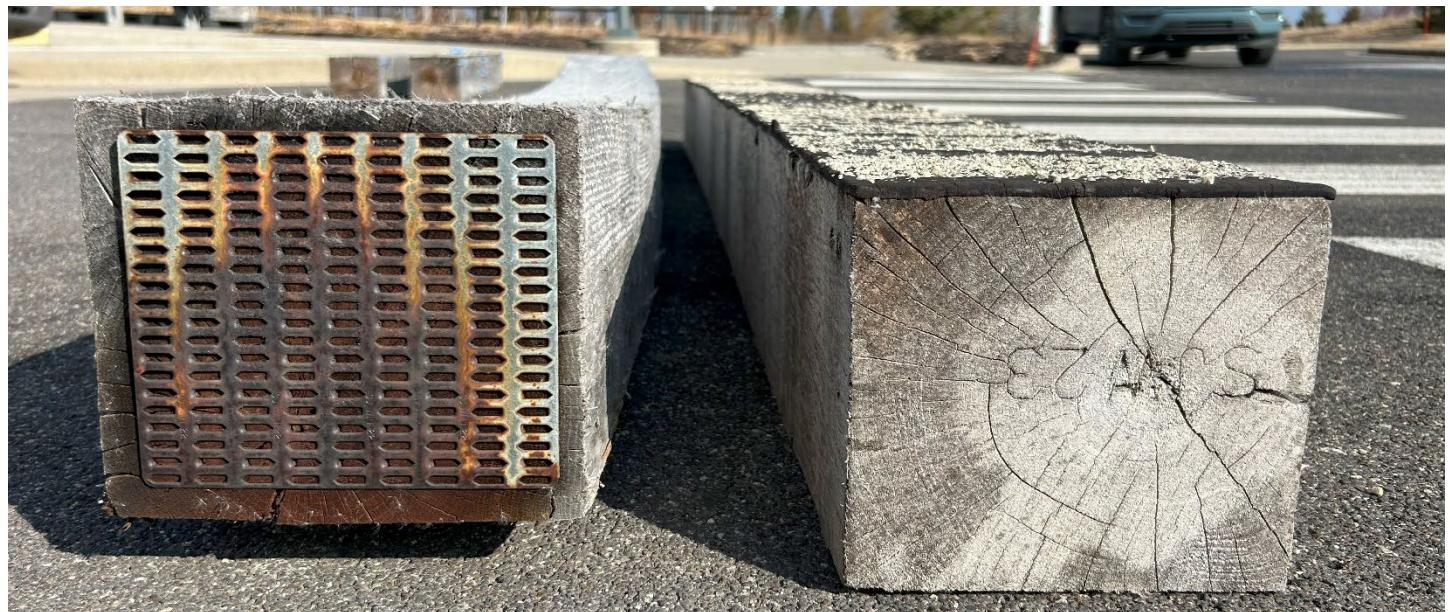
Uncoated Tie left vs. Tietan-coated Tie right

- *Uncoated Tie left Vs. Tietan Coated Tie right*
- *Left outside for 1 year and 8 months at the time of images*
- *Tietan Coating: A highly polymer-modified, weather-resistant asphalt coating applied to the top surface of the tie. Designed to protect and extend the life cycle of wood ties. Aggregate is added to ensure worker footing and safety.*

The uncoated tie (left) has warped into a banana curve. The extent of the warping is evident by holding down the far end of the uncoated tie. It bends 3-4 inches off the ground.

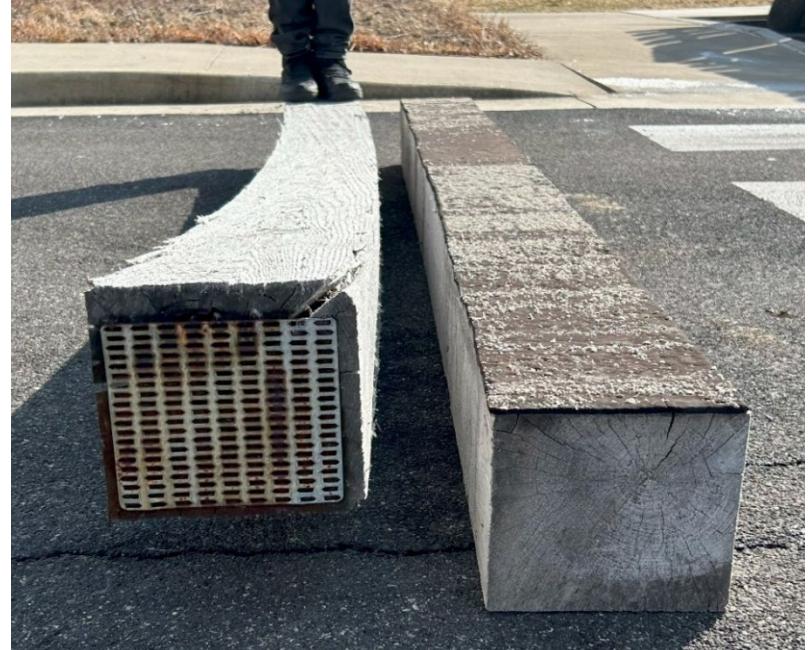
Original Wood Tie Cut in Half, One Half Coated

These two ends were once connected before the original, untreated tie was cut in half. The checks in the uncoated tie have expanded into a wide split due to UV and water damage. The coated tie remained sealed from the top, protecting the wood from top-down exposure to weather.

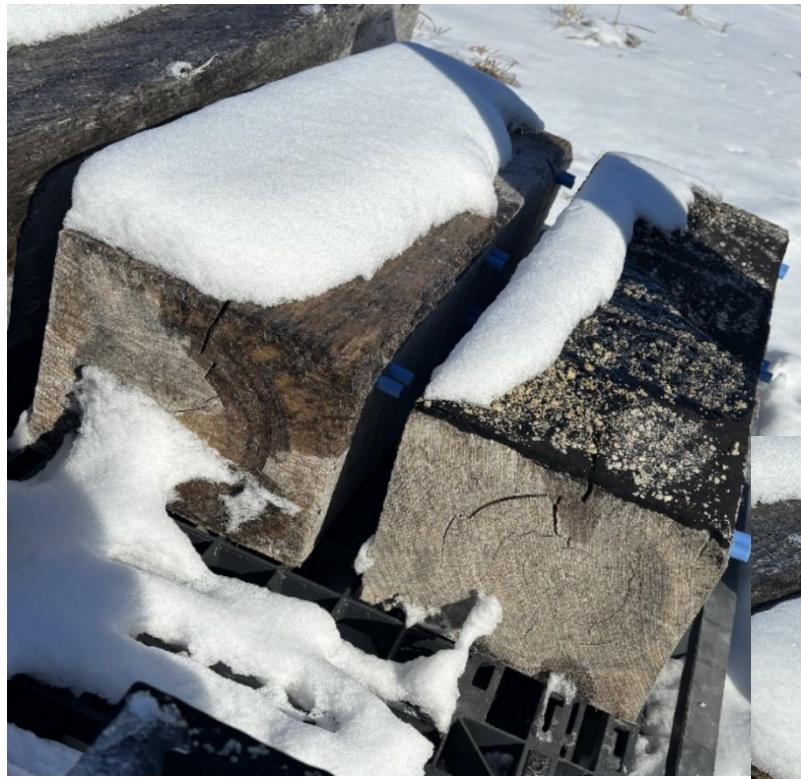
1/4 Length Ties: Uncoated vs. Tietan Coated

Look at the ends of these two sets of uncoated and coated ties. In the uncoated specimens, the snow melt has deeply saturated the wood, compared to the dry wood of the Tietan ties.
